AEDC-TR-66-226

NITROGEN TETROXIDE-STAINLESS STEEL CRYOPANEL CORROSION AND COATING DEGRADATION IN SPACE CHAMBER PROPULSION TESTING

P. G. Waldrep ARO, Inc.

April 1967

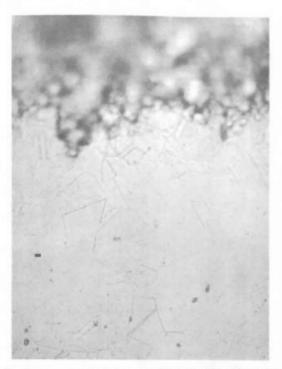
Micrographs of cross-sectional areas of the test specimens were quite revealing. Figure 7 is a view of a cross section of the corroded stainless steel 304 and shows that general corrosive attack is present on the surface. However, because a reference surface cannot be estimated, the extent of the corrosion is not ascertainable. Figure 8 shows a cross section of the heat-sensitized area close to the welds. The grain boundaries display precipitated carbides together with delta ferrite.*

Fig. 7 Microgroph of Cross Section of Stainless Steel 304 Shawing Corrosion

Carbides along Grain Boundaries
